**ALLSTAR TECHNICAL NOTE**

**Product:** Challenger S (AC9300) and Challenger GL (AC9500)

**Subject:** Operator Does Not Run Using Radio Control

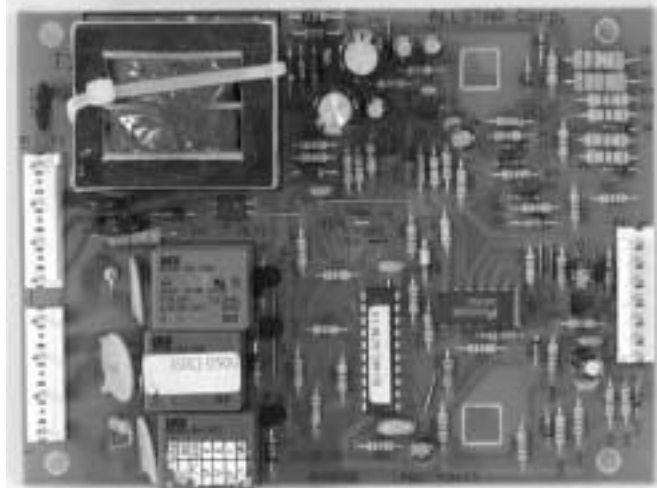
We have had some reports from customers that sometime after installation, the Challenger Operator stops working from the radio controls however continues to work properly from the wall button. Only a small number of operators have exhibited this problem. A picture of the subject control board is below.

Field returns and lab testing indicated that a component on the control board was being damaged. Under certain conditions, electrical noise from thunder storms, electrical appliances and other inductive loads could enter the control circuit, by way of the pushbutton wires, and damage electrical components on the control board. Further testing showed this problem could be virtually eliminated by upgrading a component on the control board. When tested in the lab, the control board with the new component withstood 3 times more voltage than the control board using the old component.

All products, including finished operators, replacement boards and warranty repairs, produced after June 27<sup>th</sup> will have the upgraded component installed in the control board.

**NOTE:** Low voltage wires used for pushbuttons and photobeams should never be installed next to high-voltage wires. Typically they should be routed 8-12 inches from any high-voltage wires. Other regulations may apply. Always check local building codes for current requirements.
